Garlock KLOZURE® Family of Shaft Grounded Bearing Isolators

Family of Shaft Grounded Bearing Isolators

Garlock SGi® Family - The ultimate protection for your bearings

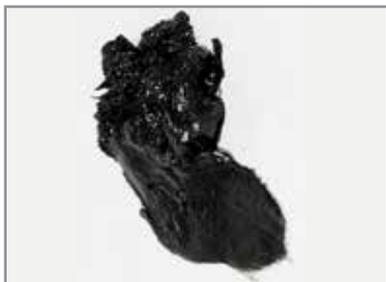
LUBRICATION DETERIORATION

Bearing protection is not just about ensuring the lubrication stays clean and retained, but also ensuring the quality of the lubricant is maintained. Continuous electrical arcing in the motor bearings will often rapidly deteriorate the quality of the lubrication and cause bearing race damage. When an arc occurs, the lubrication is super heated and causes lubrication break-down. The grease will often have a burnt/black appearance instead of the normal "clean" color. Deterioration of the grease will also result in a greatly shortened bearing life.

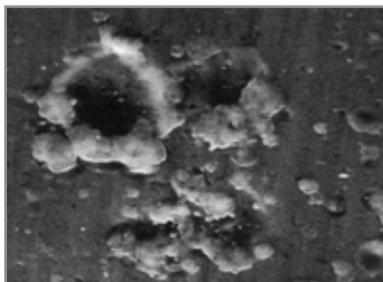
EDM PITTING & MICRO CRATES IN ROLLING ELEMENTS

Electrical Discharge Machining (EDM) is an electrical arc that is created when the shaft voltage overcomes the dielectric of the oil film between the rolling element and the bearing race. The electrical current arcs through the oil and grease and melts the steel race wall creating a pit in the surface between 5 to 10 micron diameter. These pits are visible to the eye in the form of a light colored track on the bearing race. Over time the micro craters can result in fluted bearing races.

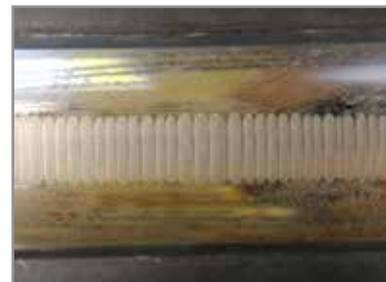
BEARING FLUTING

Bearing fluting is an accelerated "wash-board" wear pattern in the bearing race as a result of continued EDM pitting. As the rolling element travels over already damaged areas, more damage occurs. High system vibration and noise are often the result of bearing fluting which will result in costly system failure.

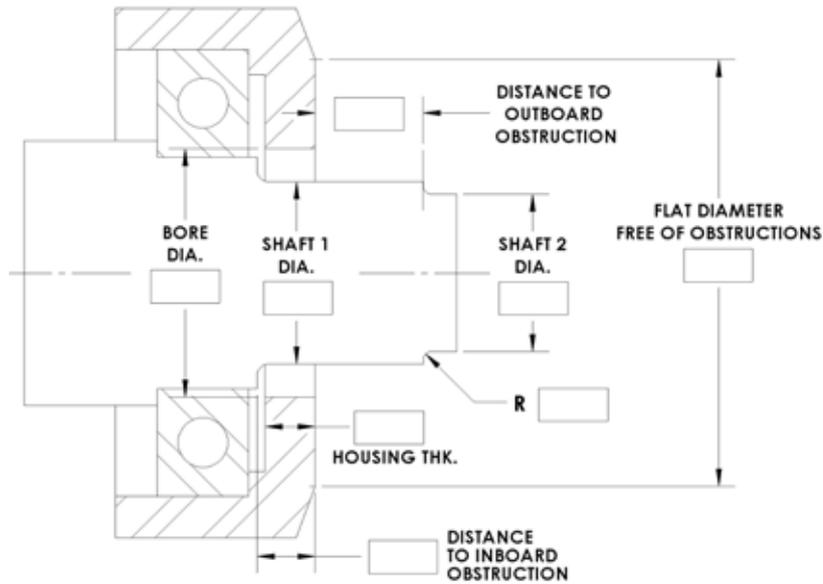
GARLOCK KLOZURE SGI® APPLICATION DATASHEET

All dimensions supplied to 3 decimal places.
